Home Inspection Report

Property Address Here

June 12, 2005

Report Number:

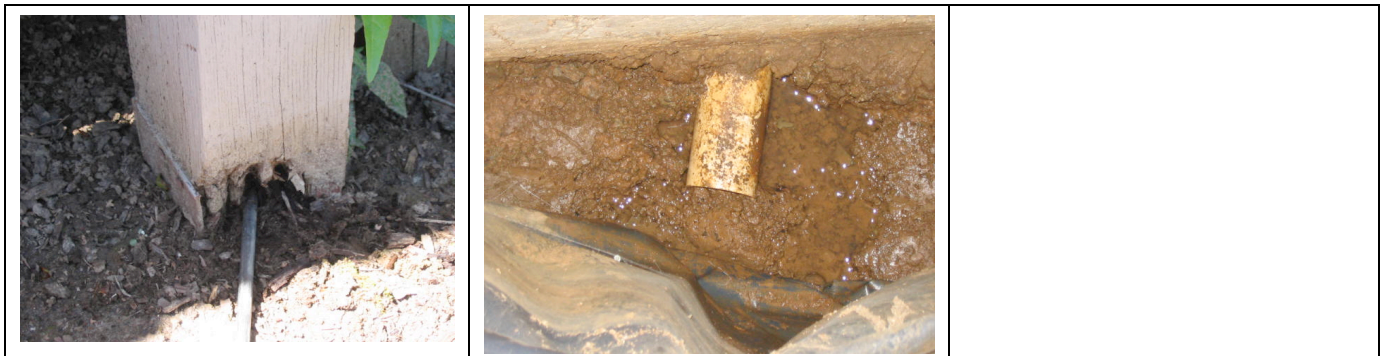
Wood Boring Insects

- **Repair:** Evidence of carpenter ant activity was observed, at the base of the front porch post. Recommend treating the ground at the base of the front porch posts.
- **Monitor:** There is evidence of past water in the crawl space. Wet crawl spaces risk building damage from rot and insects and can cause interior mold or mildew. This condition may vary seasonally and/or with precipitation intensity. Roof and lot drainage repairs or improvements should be addressed as a first step to controlling water in the crawl space (see "Exterior"). This condition should then be monitored to determine if additional, potentially costly measures are necessary to protect the building interior from water and moisture damage.
- **Improve:** Soil has filled up around the low point drain in the crawl space (center photo.) Recommend clearing soil to allow water to properly drain.

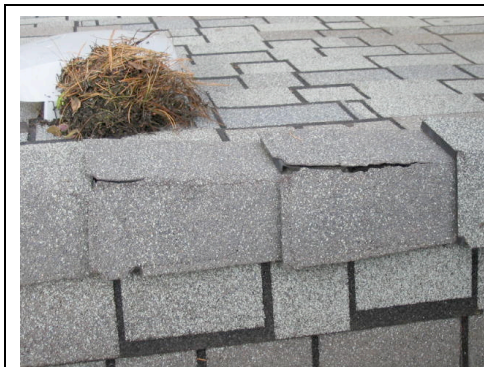
Sloped Roofing

- **Repair:** Minor repairs to the roofing are needed. Damaged ridge shingles should be repaired to prevent water intrusion (left photo above.)
- **Monitor:** The design of the roofing system is such that several vulnerable areas exist (center photo.) There is a higher potential for leaks. Annual inspections and ongoing maintenance will be critical.

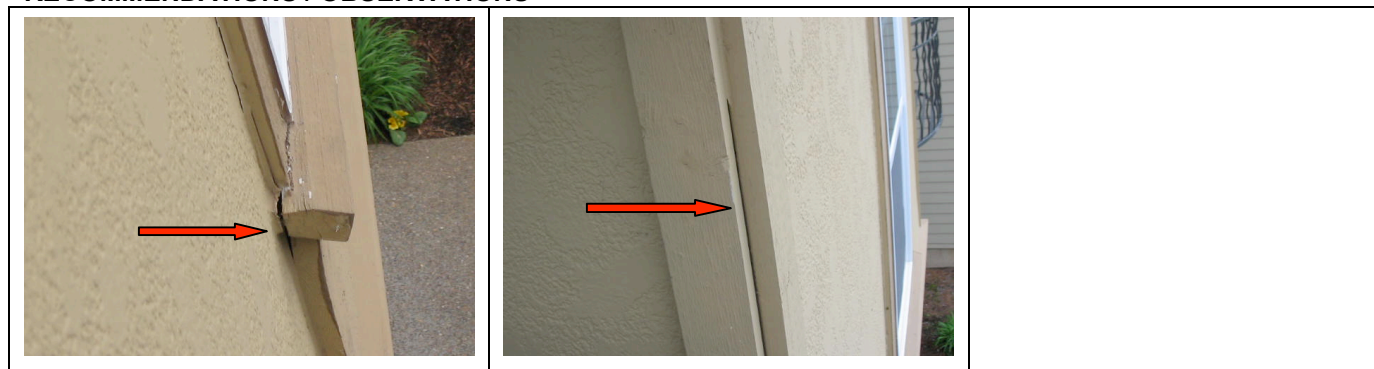
Exterior Walls

- **Repair:** Opening at window sill should be sealed to prevent water intrusion (left photo.) Location right side of office window.
- **Improve:** Corner board caulking should extend all the way down to roof line (center photo.) Location above front valley.
